230 COLINTON MAINS ROAD
FIRRHILL
EDINBURGH
EH13 9BU

Home Report

Energy Performance Certificate (EPC)

Single Survey

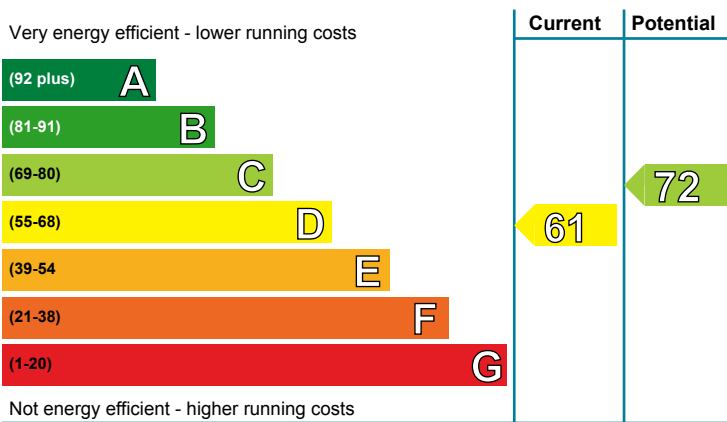
Energy Efficiency Rating

This graph shows the current efficiency of your home, taking into account both energy efficiency and fuel costs. The higher this rating, the lower your fuel bills are likely to be.

Your current rating is **band D (61)**. The average rating for EPCs in Scotland is **band D (61)**.

The potential rating shows the effect of undertaking all of the improvement measures listed within your recommendations report.
