Home Report

Scottish
Single Survey

Property address	49 Milne Meadows Old Craighall Musselburgh EH21 8TA
Customer	Mrs Hunter
Customer address	49 Milne Meadows Old Craighall Musselburgh EH21 8TA
Prepared by	Shepherd Chartered Surveyors
Date of inspection	03/12/2024

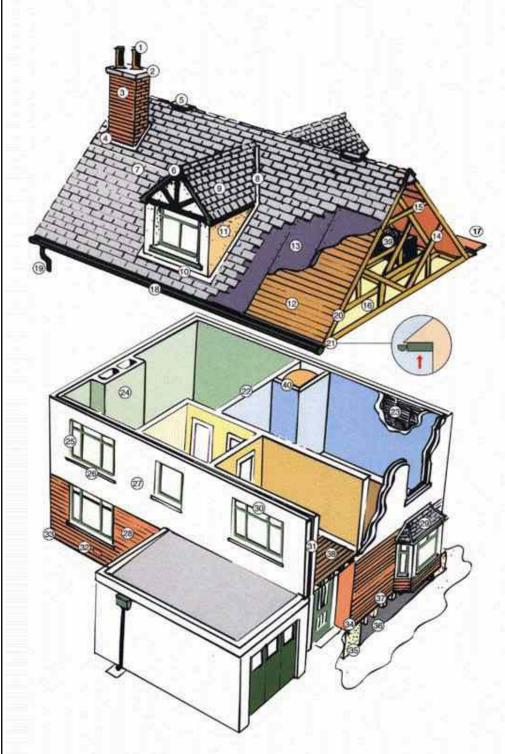
Sectional Diagram showing elements of a typical house

Reference may be made in this report to some or all of the above component parts of the property. This diagram may assist you in locating and understanding these items.

- 1) Chimney pots
- 2) Coping stone
- 3) Chimney head
- (4) Flashing
- 5) Ridge ventilation
- 6) Ridge board
- (7) Slates / tiles
- 8 Valley guttering
- 9 Dormer projection
- 10 Dormer flashing
- 11 Dormer cheeks
- (12) Sarking
- (13) Roof felt
- 14) Trusses
- (15) Collar
- 16) Insulation
- (17) Parapet gutter
- 18) Eaves guttering
- (19) Rainwater downpipe
- 20) Verge boards /skews
- 21) Soffit boards
- 22) Partition wall
- 23) Lath / plaster
- 24) Chimney breast
- 25) Window pointing
- 26) Window sills
- 27) Rendering
- (28) Brickwork / pointing
- 29 Bay window projection
- (30) Lintels
- (31) Cavity walls / wall ties
- 32) Subfloor ventilator
- (33) Damp proof course
- 34) Base course
- 35) Foundations
- 36) Solum
- 37) Floor joists
- 38) Floorboards
- 39) Water tank
- 40) Hot water tank
