Home Report

Scottish Single Survey

Property address	3 Seafield Eyemouth TD14 5BX
Customer	Jillian Lough
Customer address	3 Seafield Eyemouth TD14 5BX
Prepared by	Shepherd Chartered Surveyors
Date of inspection	13/02/2025

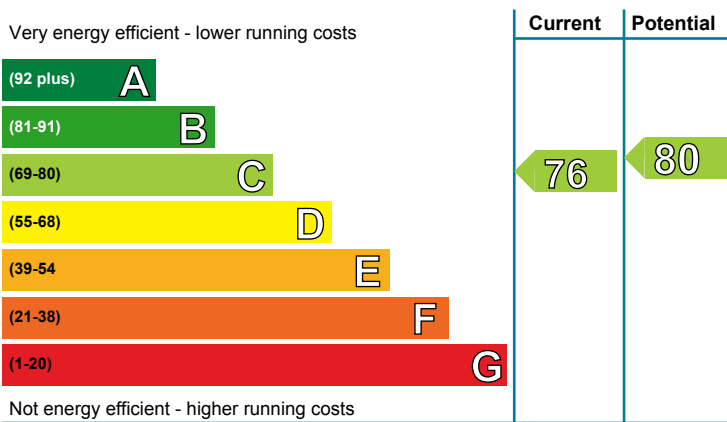
Energy Efficiency Rating

This graph shows the current efficiency of your home, taking into account both energy efficiency and fuel costs. The higher this rating, the lower your fuel bills are likely to be.

Your current rating is **band C (76)**. The average rating for EPCs in Scotland is **band D (61)**.

The potential rating shows the effect of undertaking all of the improvement measures listed within your recommendations report.
